The Martian Landscape

By The Viking Lander Imaging Team

Scientific and Technical Information Office
NATIONAL AERONAUTICS AND SPACE ADMINISTRATION
Washington, D.C. 1978

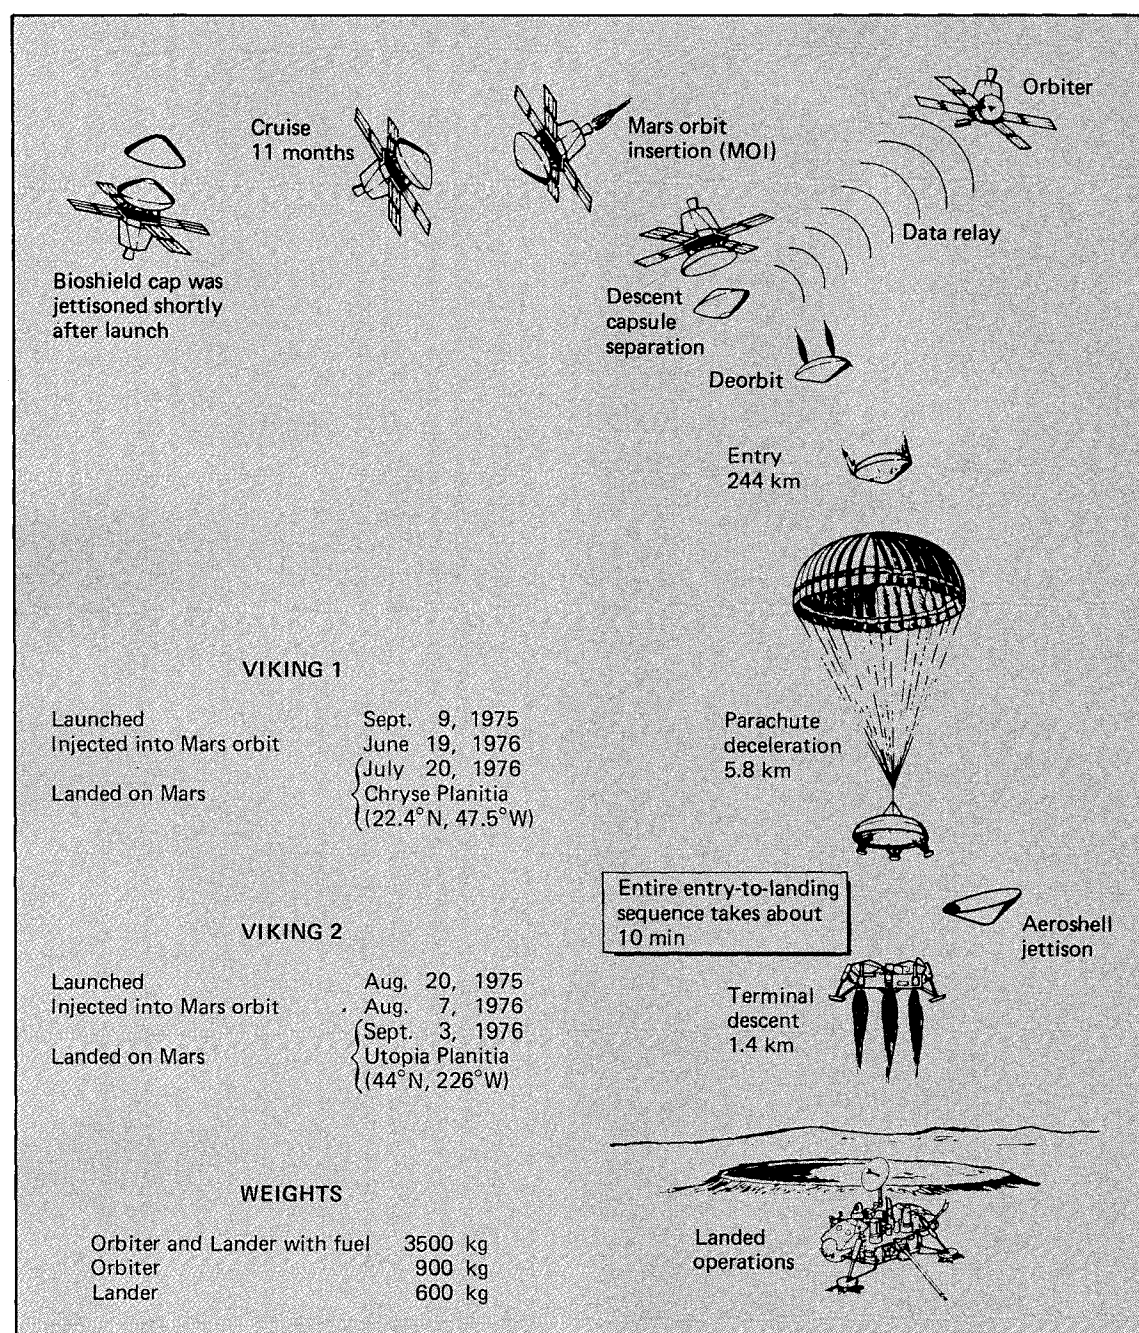
Figure 1. The sequence of events from launch to landing on Mars.

Viking included two Orbiter-Lander pairs to be placed into orbit about Mars. Following successful orbit insertion the Landers would be released and directed toward the surface. Slowed first by aerodynamic drag, then by parachute, and finally by retrorockets, they were designed for a "soft" landing. At 2.5 m/sec the jolt would be something like that encountered when jumping off a 35-cm-high stool on Earth. Except for the parachute phase, the entire sequence would be similar to that employed for Apollo landings on the Moon (fig. 1).

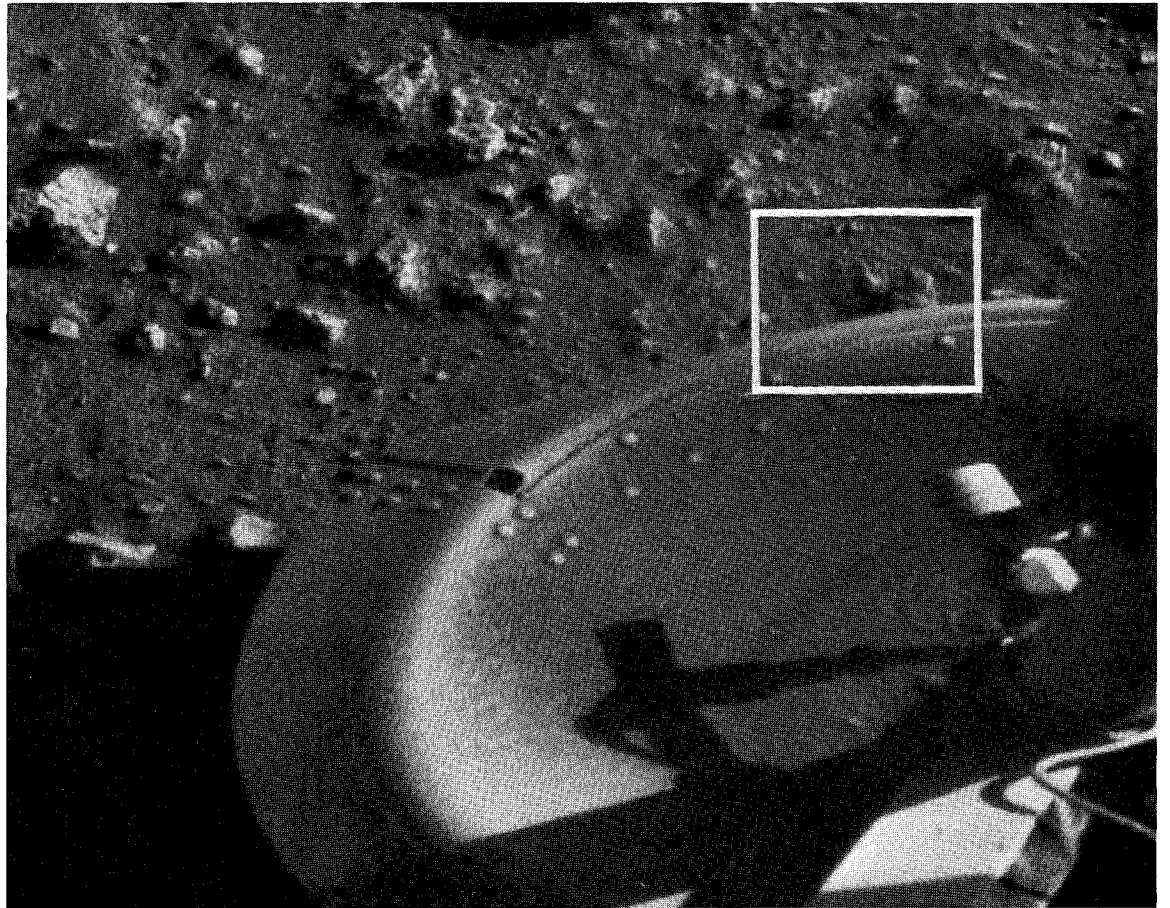
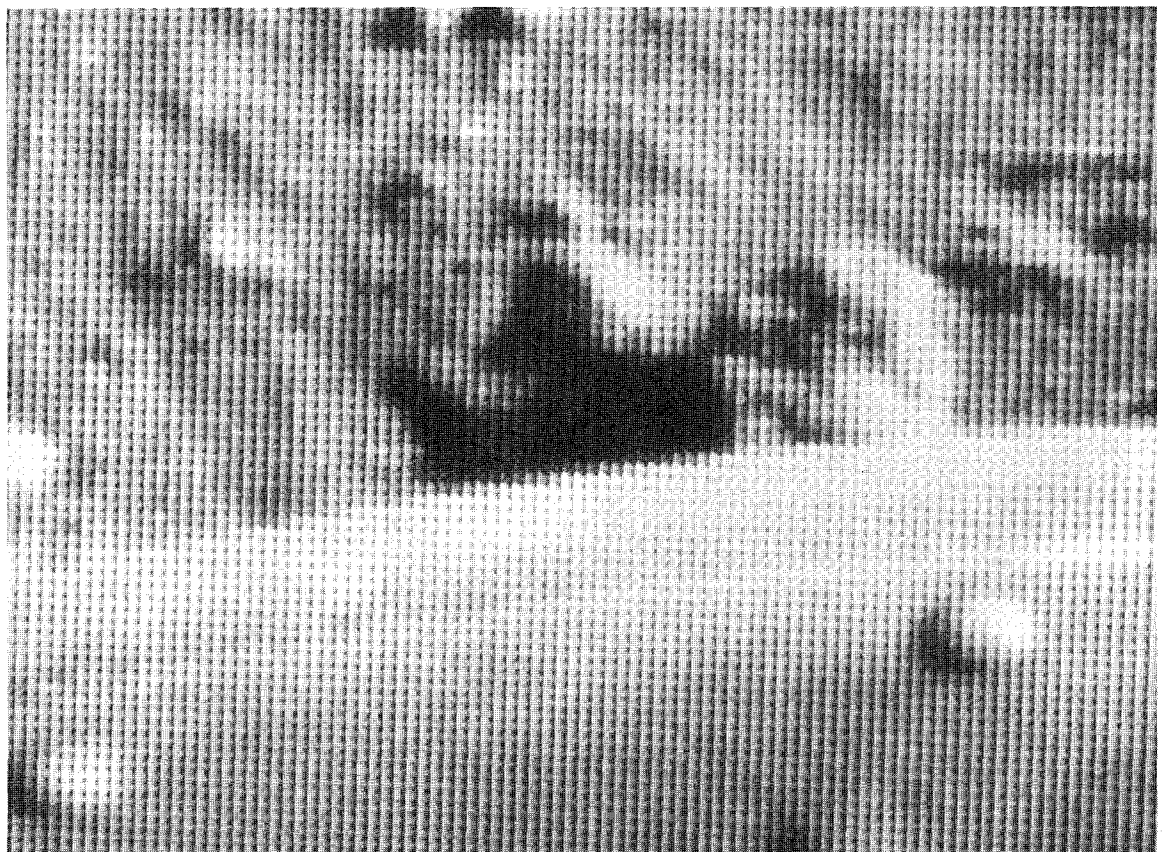
Figure 2. A part of the first picture taken on the surface of Mars, and a greatly magnified region within that picture. Note that the picture comprises a large array of discrete spots which range in brightness from white to black.

Note that the camera is described in "engineering" rather than "scientific" terms. There is an underlying tension separating the two. Take one of the more obvious camera characteristics, spatial resolution. The scientific goal is to take pictures of the sharpest clarity, showing the smallest detail. But you can't very well ask the manufacturer to give you a "best" picture. Instead we elected to specify that the resolution should be 0.04° . This is sometimes termed the camera's instantaneous field of view. The concept is best illustrated by looking at an enlargement of a Viking picture (fig. 2). With high magnification the image is seen to comprise a regular checkerboard of spots, each with a particular shade of gray. Each space on the checkerboard approximates a circle which subtends 0.04° as viewed from the camera position. A single trace of 360°

includes 9000 checkerboard squares. A 60° swath in elevation includes 1500. A large panorama, 60° by 360°, comprises the impressively large array of 13½ million checkerboard squares, or pixels (picture elements).

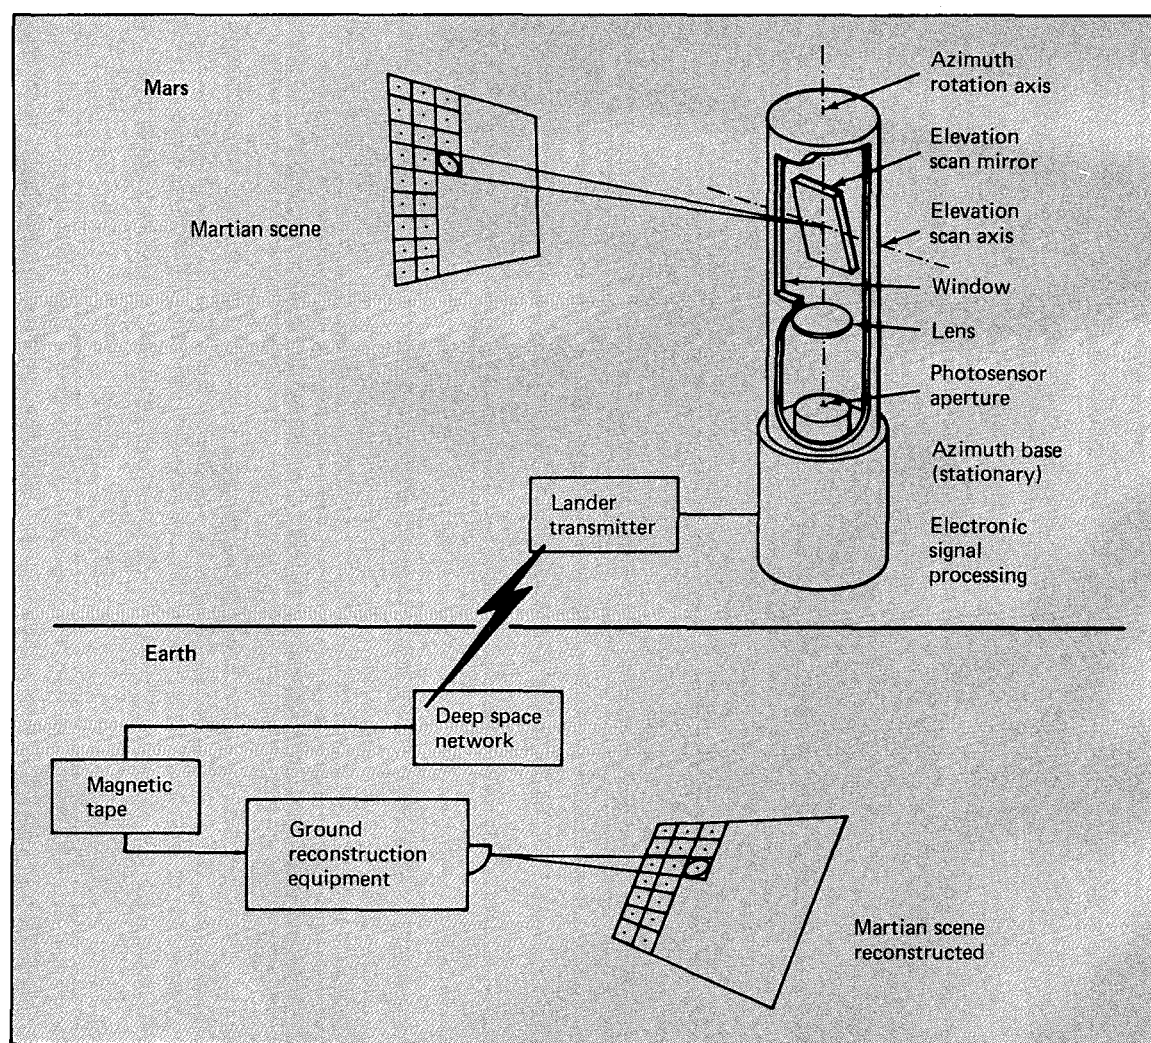
Figure 3. Schematic configuration of the Viking Lander camera and related equipment.

A simplified view of the camera configuration is shown in figure 3. Light from the scene is reflected from a mirror, nodding back and forth around a horizontal axis. Focused through a lens system, it is recorded on a photosensor in the focal plane. Each time the mirror nods, light from successive points along a single apparent vertical line in the object scene is recorded by the photosensor. When this cycle is completed, the entire upper assembly of the camera moves a small amount around an azimuth rotation axis so that an adjacent vertical line is scanned. As more and more vertical lines are recorded the picture builds in the azimuthal or "horizontal" dimension, moving from left to right, and, given enough time, providing a continuous panorama up to 342.5° .

The camera employs an array of twelve photosensors (photodiodes), any one of which can be used to acquire a picture. Some of the diodes are mounted at different focal positions to achieve optimum focus at various distances. Others are equipped with filters. Measurement of "blue," "green," and "red" light permits construction of color images. Each line is scanned successively with each of three photodiodes to record the relative contributions of blue, green, and red light. Then the adjacent line is scanned three times. For color pictures the pixel size is 0.12° instead of 0.04° . The increase

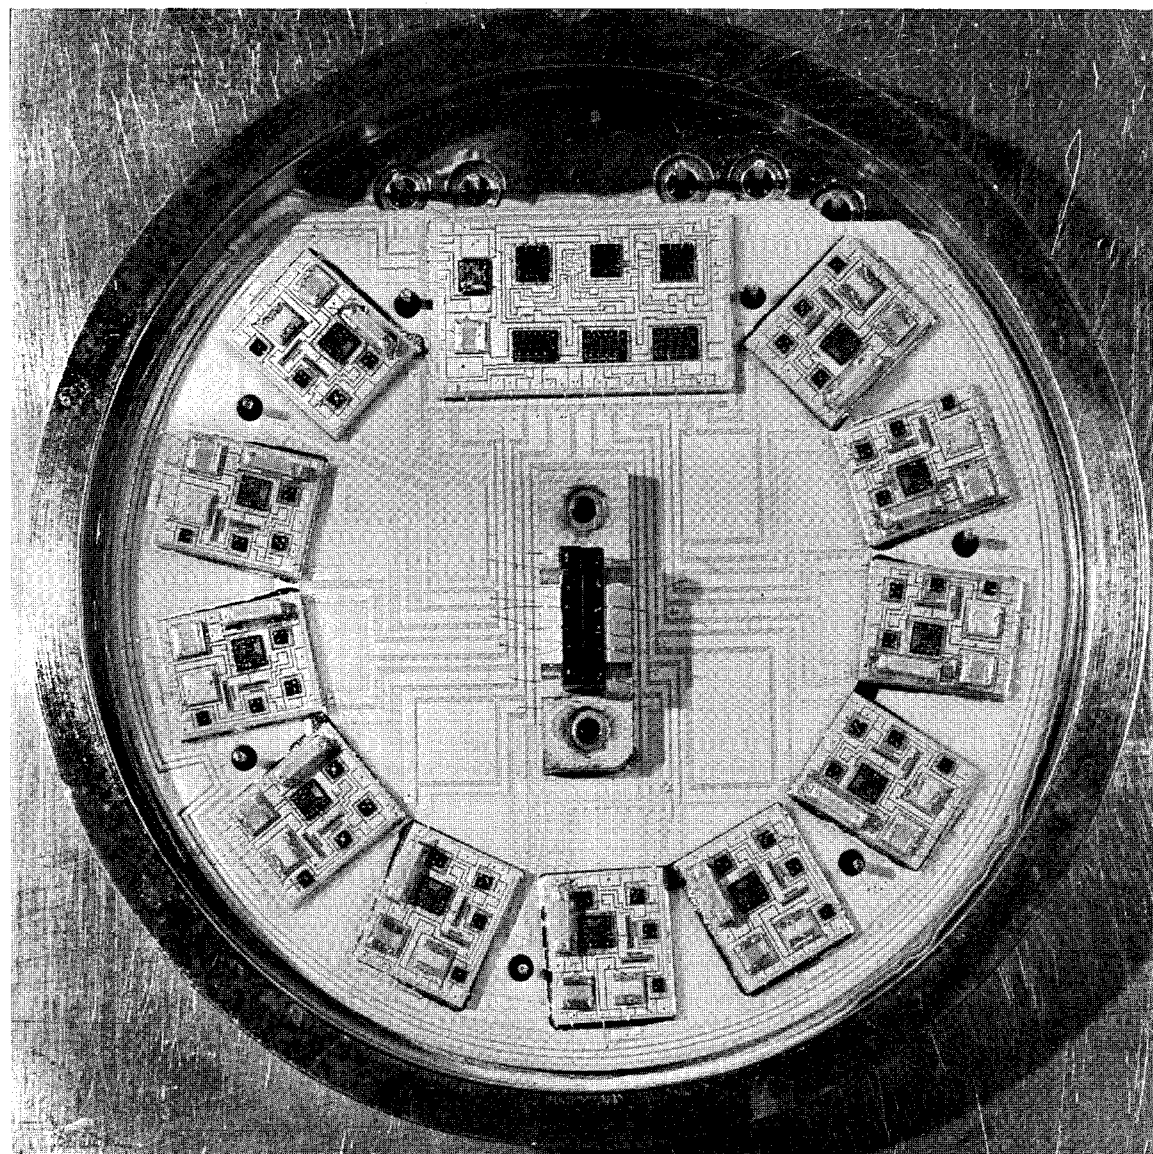
Figure 4. The photosensor array, the retina and optic nerve of the Viking camera. The entire assembly is 3.4 cm across. The 11 square circuits around the edge are preamplifiers. The rectangular circuit at the top of the array is the command module. The 12 photodiodes are mounted on the dark rectangular block in the middle, which measures approximately 6 mm by 2 mm.

The photosensor array represents a difficult problem in miniaturization. The aperture over each high-resolution (0.04°) diode is 0.041 mm in diameter. Even though so small as to be barely detectable with the unaided eye, the size of the aperture must be carefully controlled, within several thousandths of a

millimeter. The entire assembly, including twelve diodes and associated preamplifiers is only 3.4 cm in diameter and 2 cm high (fig. 4).

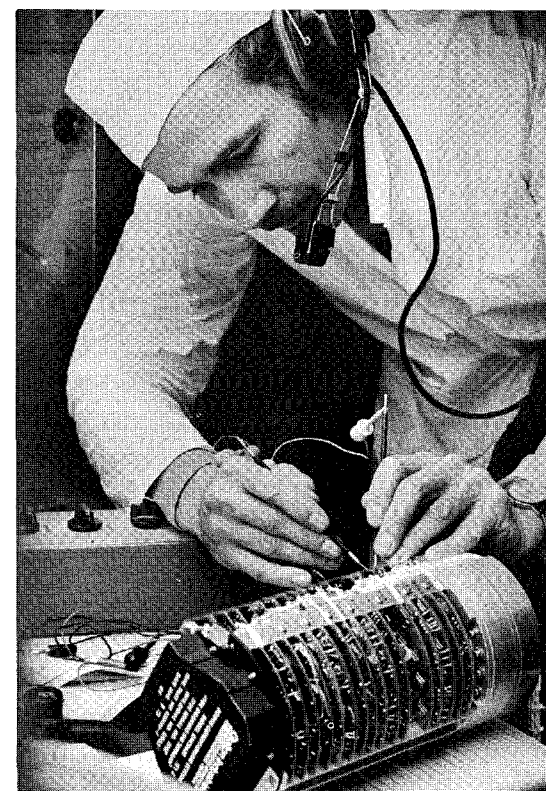
Figure 5. Checking performance of the camera electronics. The technician uses the headset to communicate with a second person who observes the quality of the video signal, displayed on a television monitor in another room.

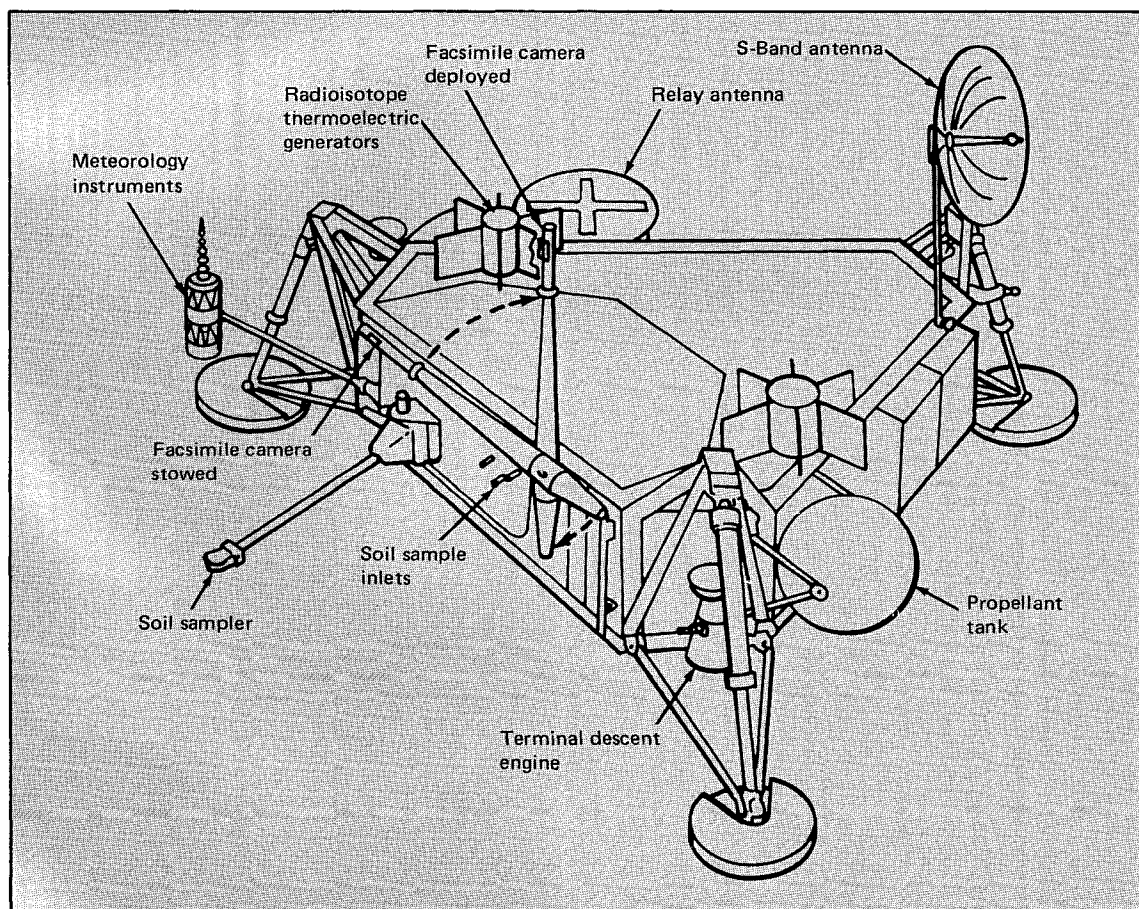
Figure 7. Initial conceptual design of the Viking Lander. A single camera is mounted on a hinged mast that can be extended vertically after it swings up.

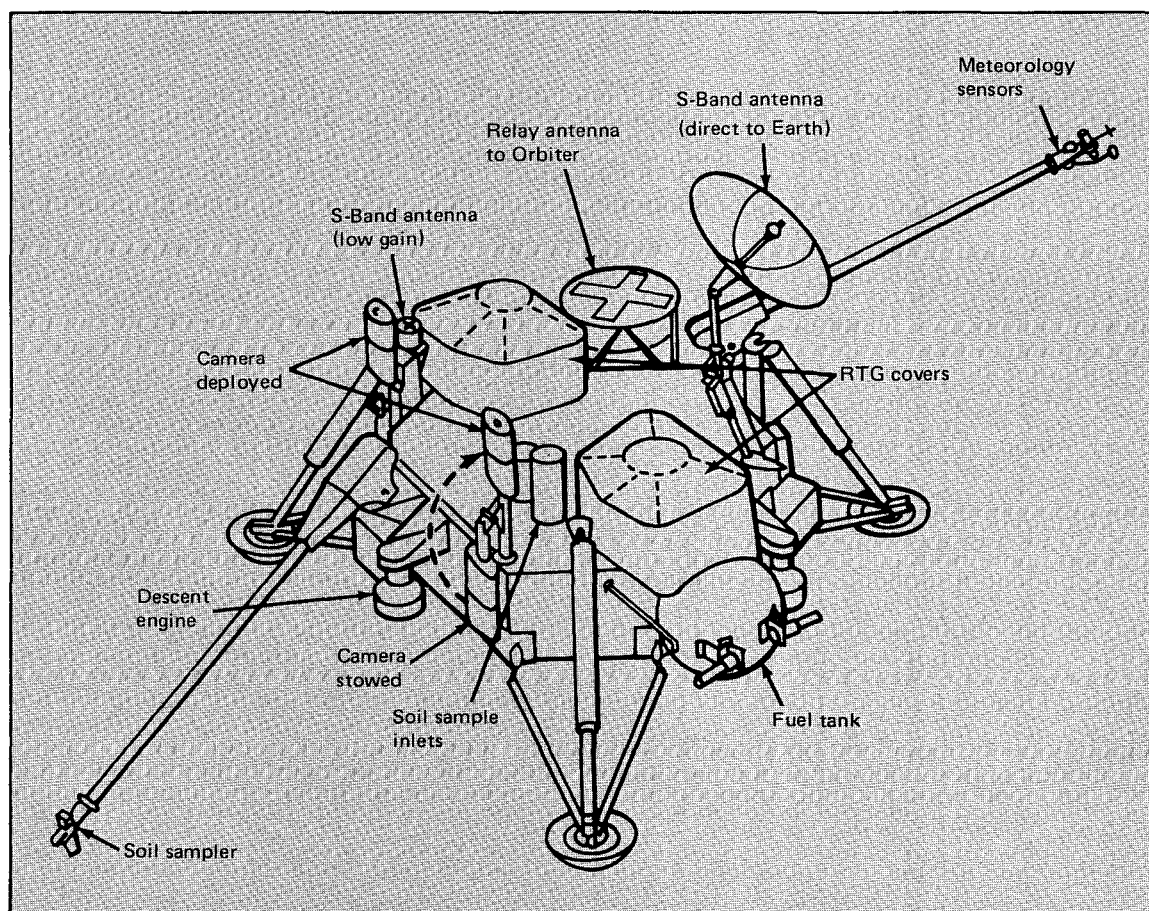
Figure 8. An intermediate design of the Viking Lander showing two cameras on hinged masts.

A compromise design was pursued for the better part of a year. The cameras would be mounted on hinged masts (fig. 8). During the trip to Mars they would be folded down; after landing they would be swung up, rotating through 180°. In retrospect it is difficult to see how this design concept survived for as long as it did. It introduced undesirable complexity and serious risk. During landing the sensitive camera electronics would be situated close to the base of the spacecraft, susceptible to collision with a boulder. If the swing mechanism failed to operate the cameras would remain in an inoperative position. If dust coated the exposed upper plate and base of the two mast sections, the deployed camera might be slightly tilted, introducing an unknown error in topographic analysis. Finally, if the cameras were not securely connected to the body of the spacecraft, they would not benefit from heat conducted from radioisotope energy sources. Isolated on the top of articulated masts, they might freeze to death. When all the liabilities were spelled out, the swing-up masts were discarded.

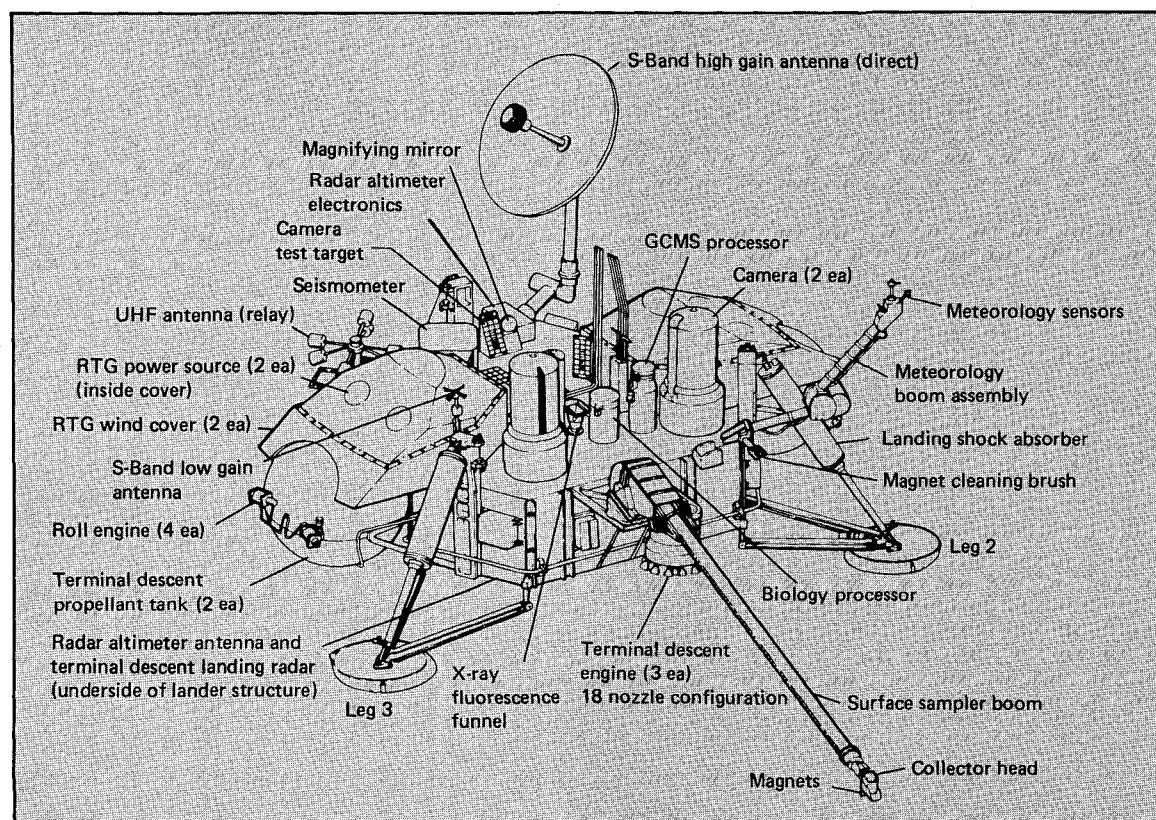
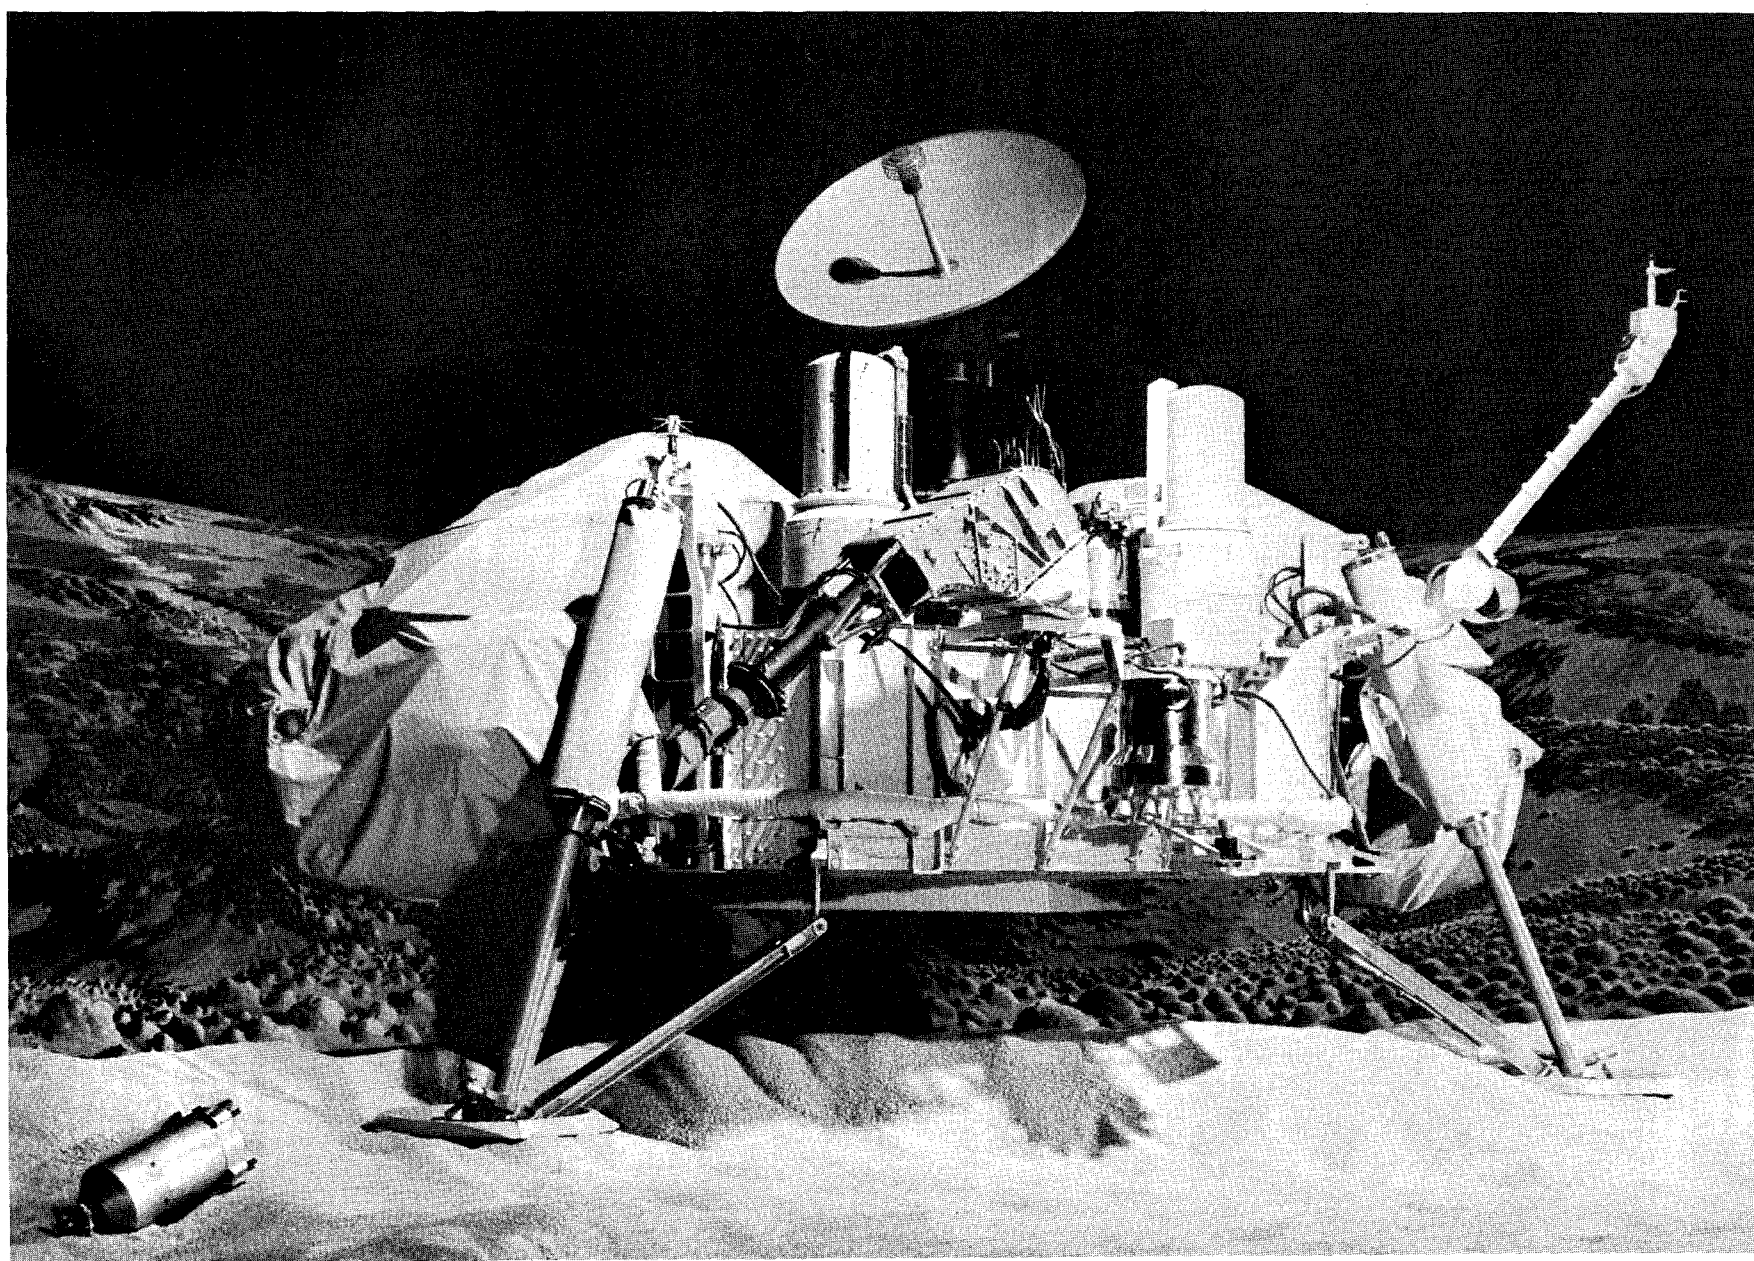
Figure 9. Schematic view of the final design for the Viking Lander.

Figure 10. The Viking Lander. Many of the science components are identifiable, including the two cameras, the meteorology boom, and the partly extended surface sampler arm. This is a spare backup Lander used for testing. During the operational mission it was used at the Jet Propulsion Laboratory to demonstrate the feasibility of surface sample sequences planned for the spacecraft on Mars. The background painting reflects the general prelanding concept of the martian surface.

The solution was to mount two cameras on short stubby masts. (See figs. 9 to 11.) Although this fulfilled weight and thermal requirements, it dismayed the scientists. A third of the field of view below the horizon would be blocked by the Viking Lander. Especially severe was obscuration of the near field where we had our only opportunity to photograph the surface with high spatial resolution.

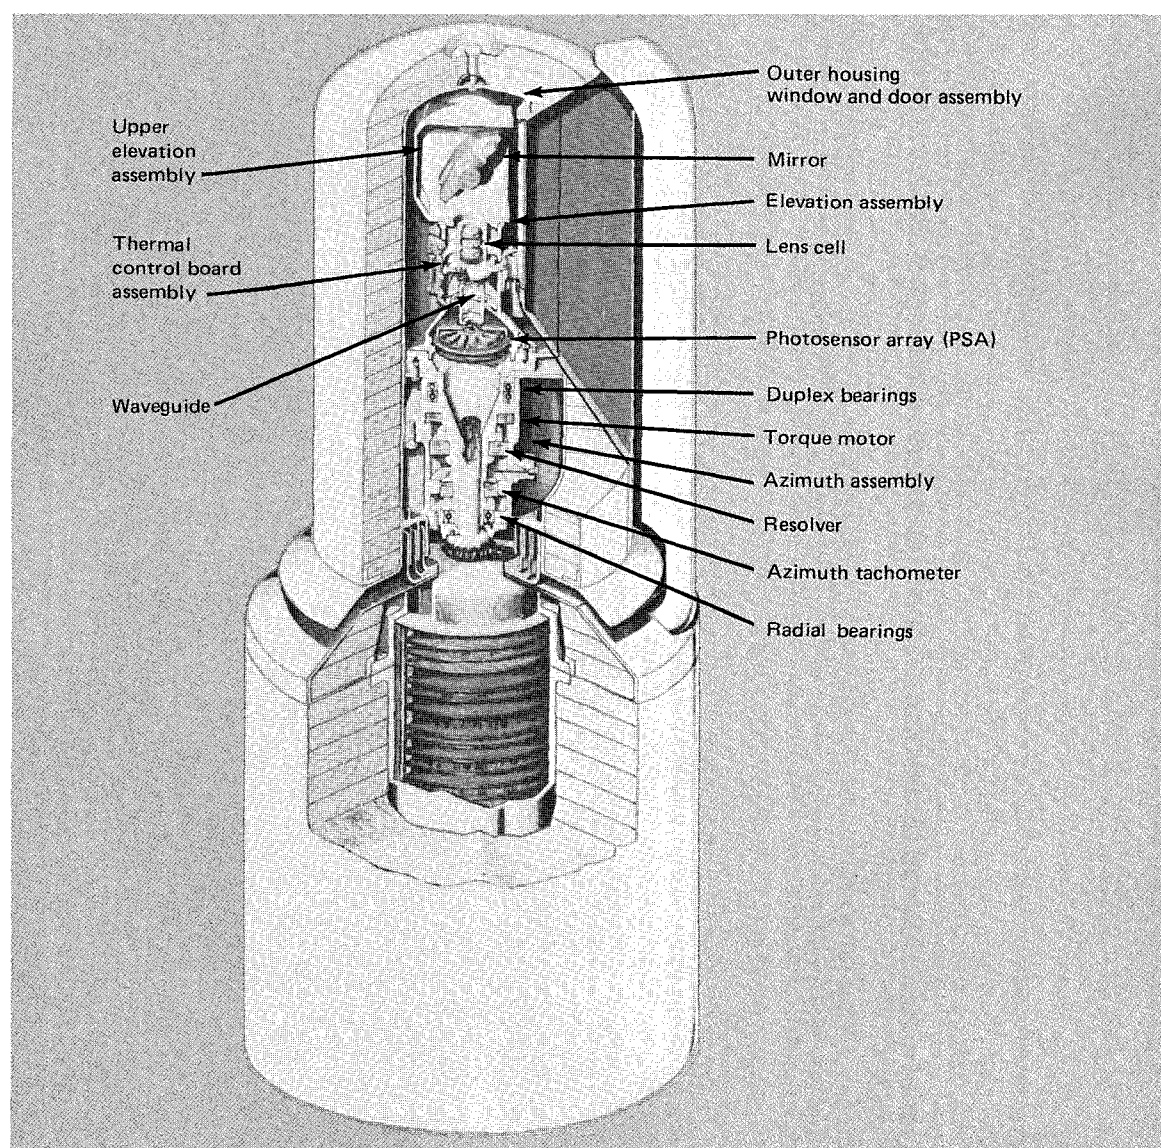
Figure 11. A cutaway drawing showing arrangement of components in the Viking Lander camera.

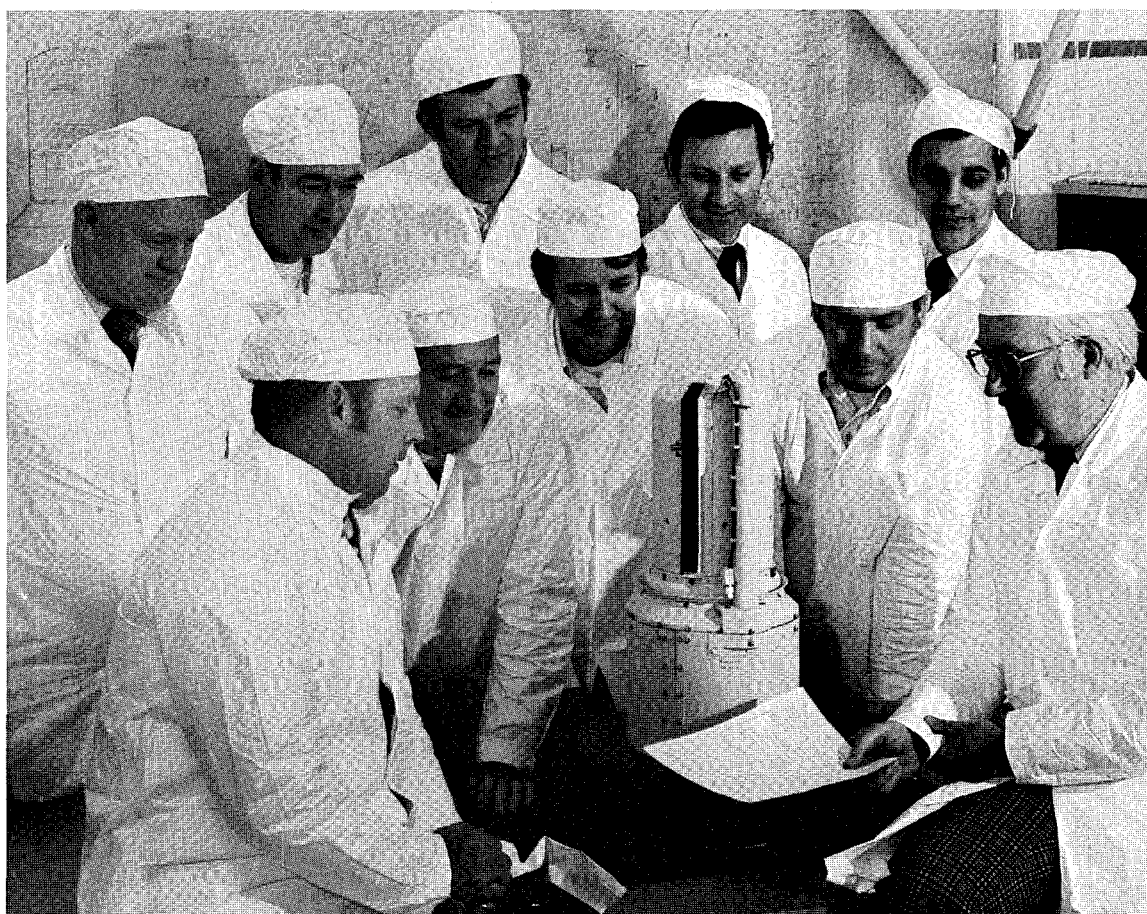
Figure 12. Members of the ITEK team dramatizing (some persons might say overdramatizing) an important event—delivery of the first camera to Martin Marietta. The upper and lower camera housings are distinguishable. The fixed post, attached to the top of the lower housing, is situated to the right of the recessed camera window.

the real problem. There was very little clearance between the upper camera housing and the fixed post against which the recessed window was stowed when the camera was not in use. As the temperature was lowered the post flexed and pressed against the upper housing. The clearance between post and housing was adjusted slightly and the problem never recurred.

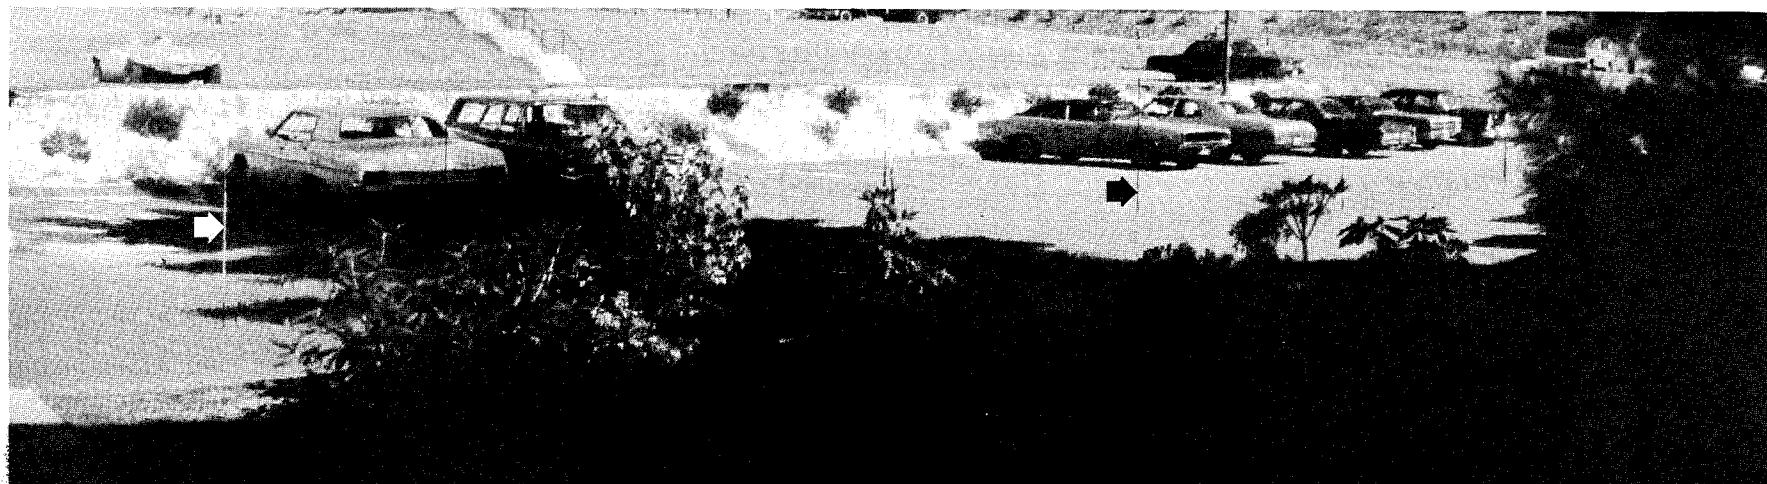
Figure 13. The first panorama taken with the Viking camera, a view of the ITEK parking lot in Lexington, Mass. The several vertical streaks, indicated by arrows, are not defects. They are the greatly distorted images of cars that drove by while the picture was being taken.

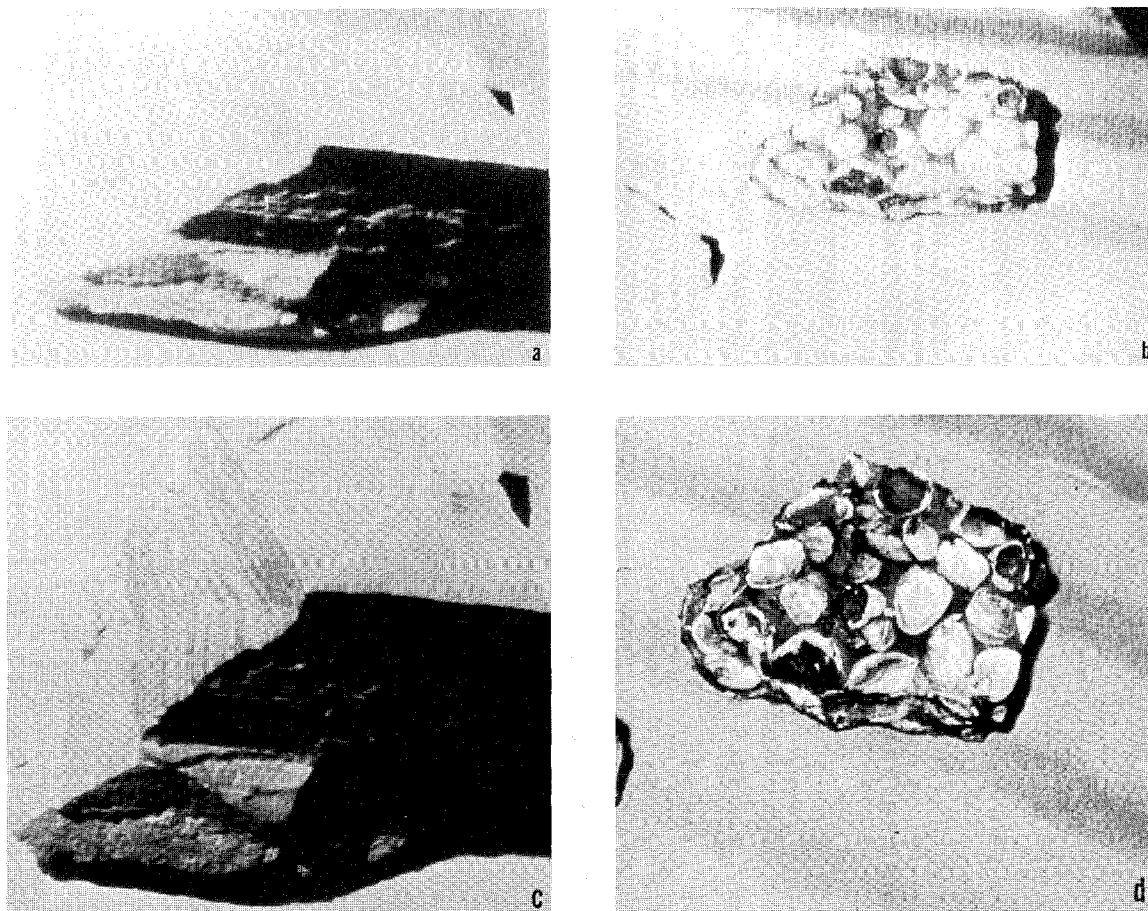
Figure 14. Pictures of (a) a layered sedimentary rock and (b) a fossil-rich rock, both taken with the Viking breadboard camera, and comparable images (c) and (d) taken with a conventional film camera.

The first extensive science test of the camera was conducted in August 1971. We used a prototype camera, picturesquely referred to, in engineering parlance, as a breadboard model. To the considerable amusement of ITEK personnel, several of my graduate students arrived at the camera facility with a box, one meter square, filled with sediment and rocks. Naturally enough it was irreverently known as Mutch's sandbox. We took pictures of assemblages of sand and rocks both with the Viking camera and with a conventional film camera. To our delight we discovered that many diagnostic features were visible in Viking camera pictures (fig. 14). The images were marred by vertical banding

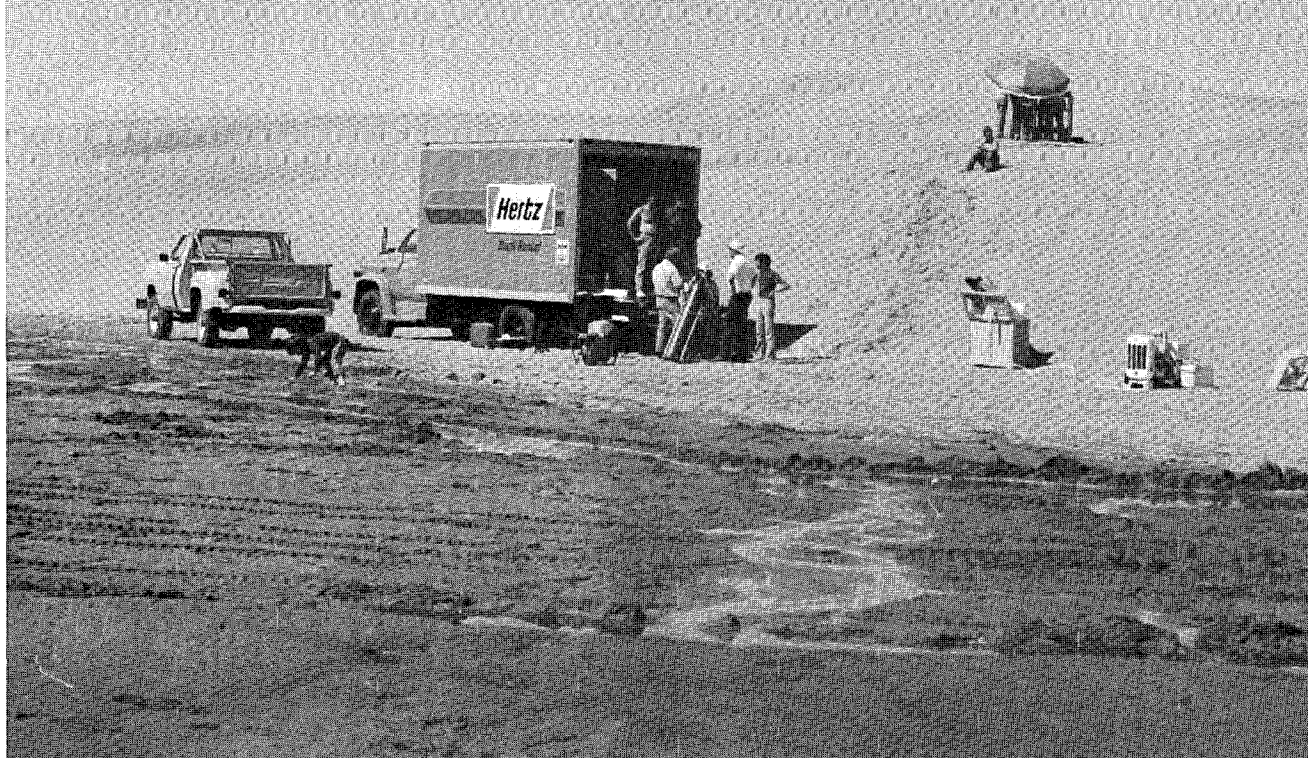
Figure 15. Operating the Viking camera at Great Sand Dunes National Monument, Colo. The camera is situated beneath the umbrella which protects it from the heat of the Sun. The supporting electronic equipment is in the rental truck.

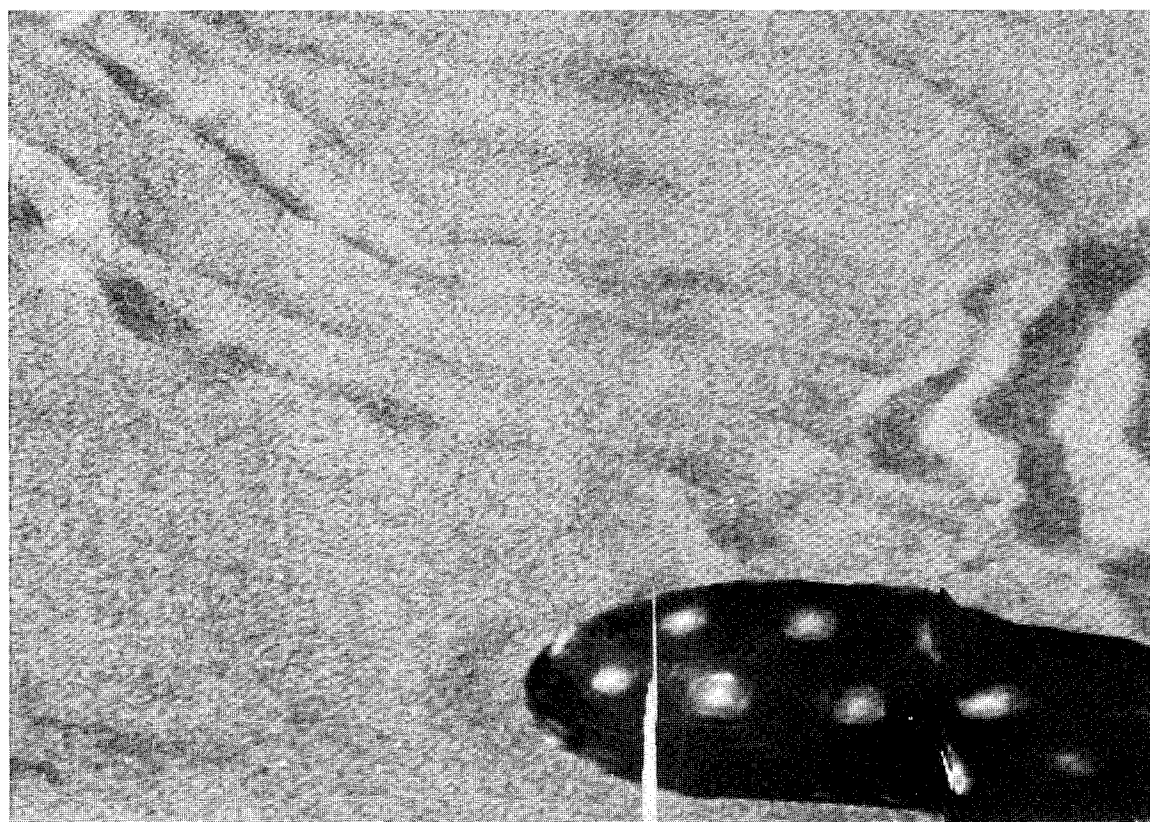
Figure 16. This picture was taken at Great Sand Dunes National Monument. A turtle, about 15 cm in length, began moving across the field of view after the camera had almost completed scanning it at rest. Because the turtle moved in the same direction as the camera scanned, it appears more elliptical than it really is. Turtle tracks in the background are deeper and more irregular than the natural sand ripples.

We had no success photographing the snake. Every time we placed it on the hot sand it skittered away before the camera could be turned on. With the turtle we had more luck. Several pictures recorded its artificially distended shape as it moved across the field of view (fig. 16).

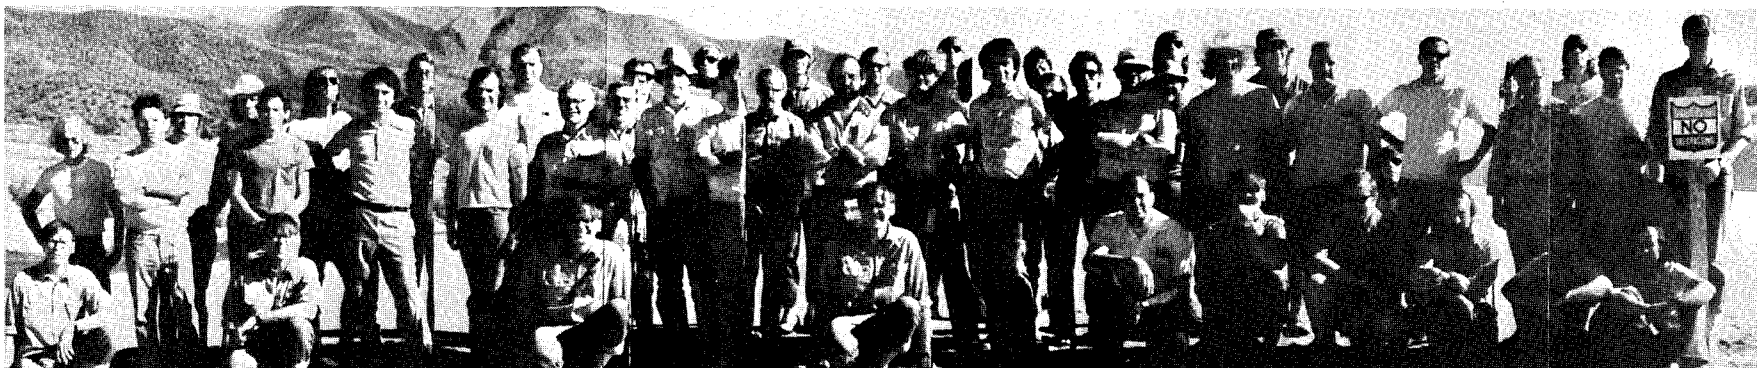
Figure 17. This picture was taken at the conclusion of testing at the Great Sand Dunes National Monument. Because the camera scans slowly in azimuth from left to right, it was possible for some of the participants to position themselves in the field of view several times. Artificially clipped bodies appear where people moved before the camera had completed scanning the sector in which they stood.

For a last picture, I suggested a group portrait. After the usual demurrer that accompanies any request to have your picture taken, everyone lined up and the camera began its slow clockwise sweep. The opportunity for replication was irresistible. Looking into the central slit of the camera, we could estimate when the scanning mirror had passed on to our left. Quickly running around behind the camera we could take our place for a second portrait. In this way I managed to be photographed a record number of seven times (fig. 17).

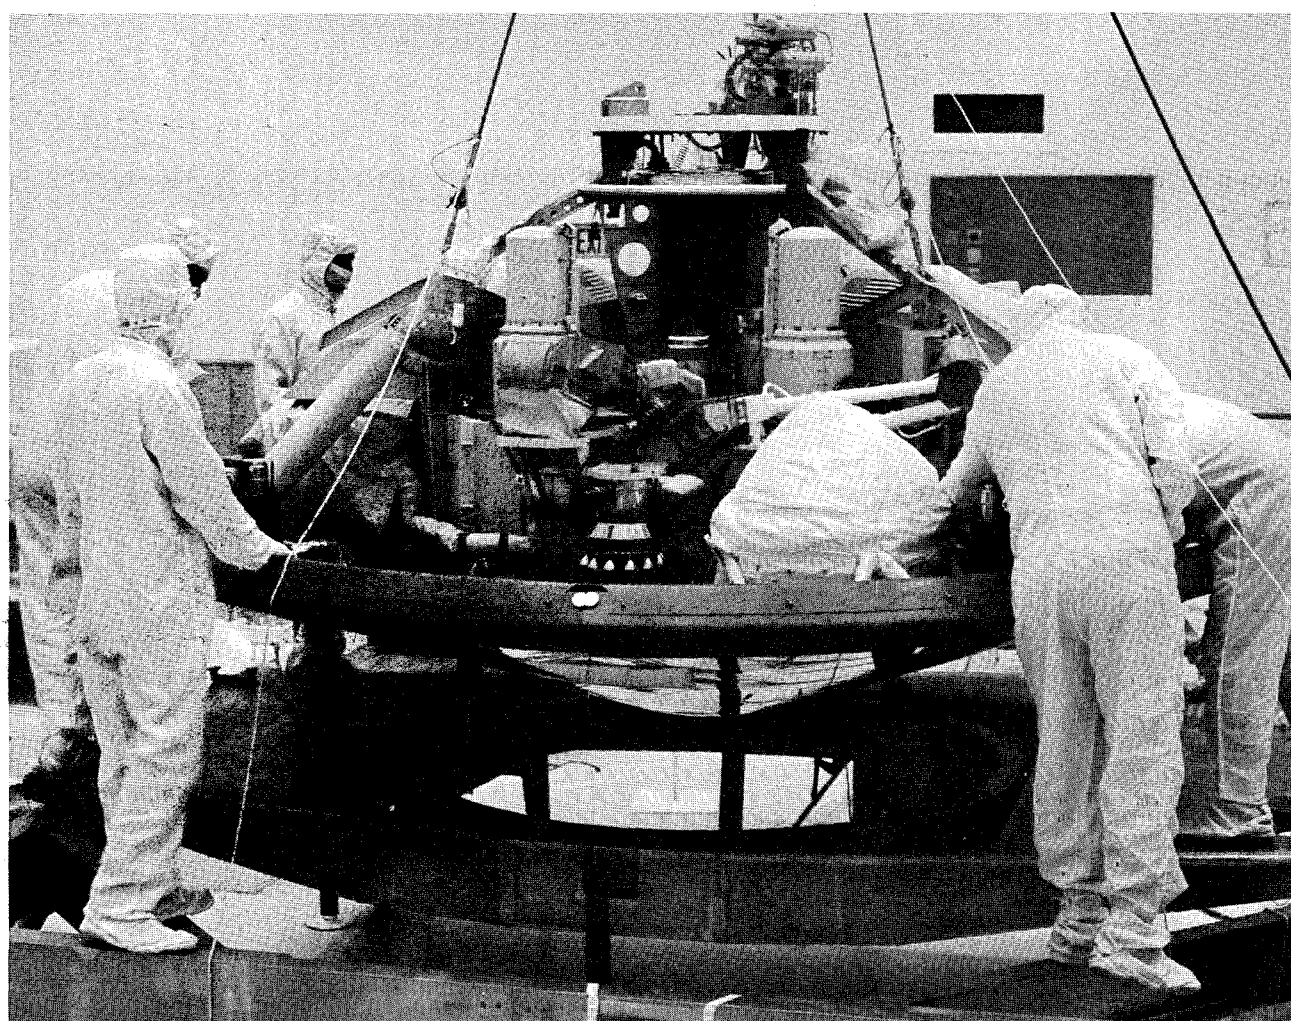
Figure 18. Encapsulating the Viking Lander in its protective aeroshell. The two Lander cameras are visible.
